NASA Technical Memorandum 102423

Strength and Toughness of Monolithic and Composite Silicon Nitrides

Jonathan A. Salem
Lewis Research Center
Cleveland, Ohio

January 1990

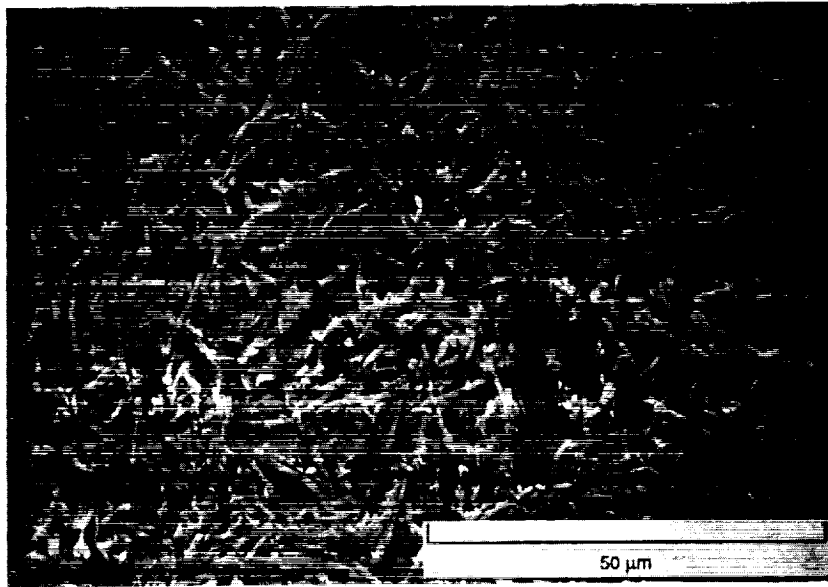
Figure 7. - Whiskers in Garrett SiC_w/Si₃N₄ exposed via plasma etching.

Typical microstructures are illustrated in figures 5 and 6. The whisker distribution in the Garrett composite was somewhat heterogeneous, with the whiskers distributed randomly in some regions and oriented in others. Whiskers, shown in figure 7, were revealed with a modified plasma etching procedure (ref. 6). The procedure did not work well on the Norton material because of the short whisker lengths.
